Bridge Photographs

BRIDGE: FORT STREET BRIDGE (STRUCTURE ID NO. 82 1820710000000B04) DATE: OCTOBER 1998

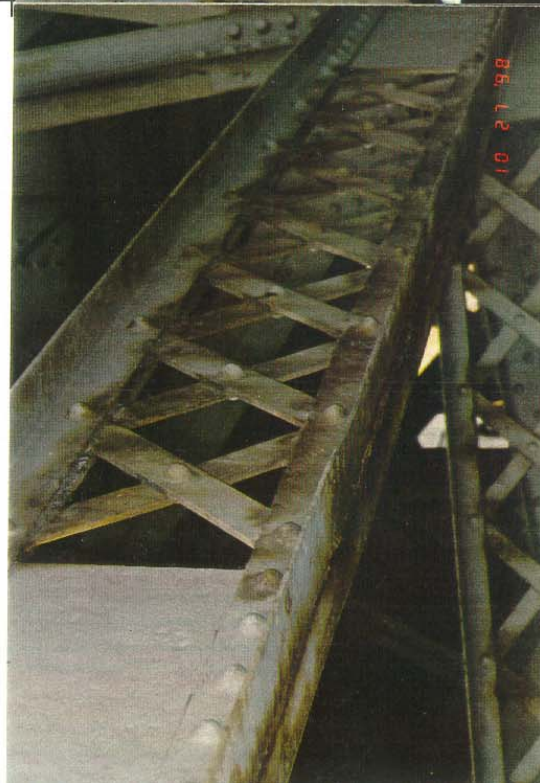
PHOTOGRAPH S-11 - View showing typical corrosion between back-to-back angles of floorbeam lower struts and reduced horizontal flange angle legs.

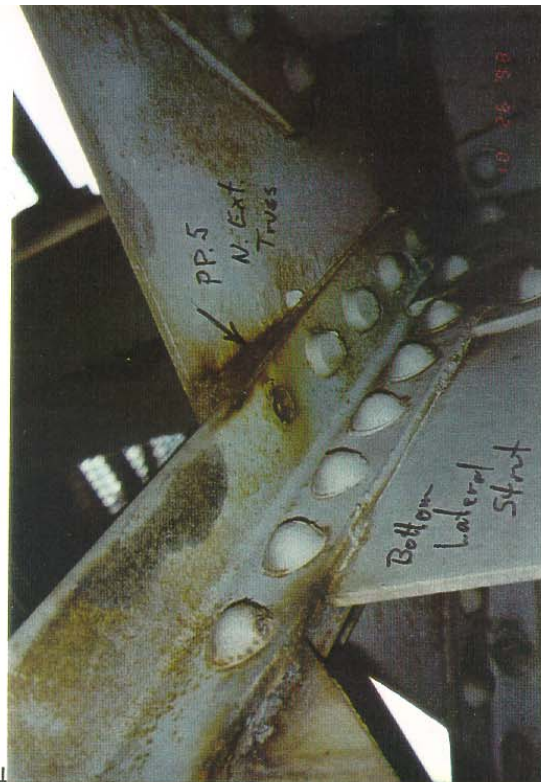
PHOTOGRAPH S-12 - View showing loss of floorbeam lower strut fastener due to occasionally occurring pack rust at inboard truss upper connection plates.
